**Flood Control Project Maintenance
Levee Inspections**
LMA District Cover Sheet
Spring 2020 Levee Inspection Results

Lower San Joaquin Levee District

Spring 2020 Levee Inspection Results

Waterway			Bank	Unit Miles
Unit No. 01 San Joaquin River			Right	22.52
	Spring (March - May)	Summer (June - August)	(September - November) Fall	Winter (December - February)
Unit Maintenance Rating (Fall Only)				
Date of Inspection	4/21/2020 - 4/21/2020			
DWR Inspector	Corey Fujitani			
Accompanied By

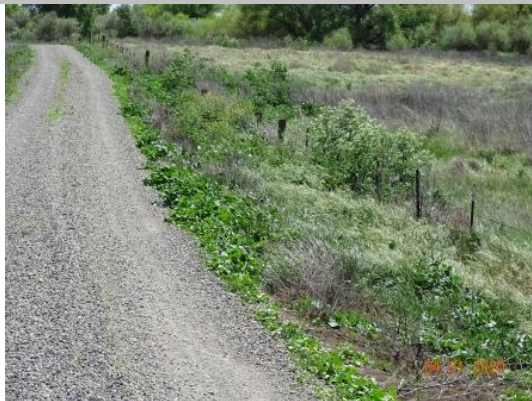
Photo 1 of 1 : SP_2020_NA0010_118_169_20200506_00309.jpg

LM Start	22.06	Rating **	U	Issue No.	169
LM End	22.51	Issue Type +	Ma	Location *	WS
Category	Earthen Levee			GPS Latitude/Longitude	
				Start	End
Item	Vegetation			37.172090 °	37.166967 °
				-120.754635 °	-120.750072 °
DWR ID	DWR_NA0010_01_s_2020_169				
Comment Code					
V1 : Control annual grass and weeds on the levee slopes and easements.					
Inspector Comment

Looking upstream along the waterside slope. (Spring 2020)

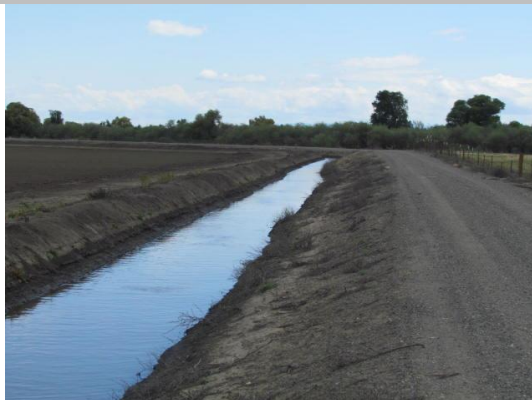
Photo 1 of 1 : SP_2020_NA0010_118_22_20200225_00012.jpg

LM Start	22.06	Rating **	U	Issue No.	22
LM End	22.52	Issue Type +	En	Location *	LS
Category	Earthen Levee			GPS Latitude/Longitude	
				Start	End
Item	Encroachments			37.172074 °	37.166906 °
				-120.754628 °	-120.749962 °
DWR ID	DWR_NA0010_01_s_2020_22				
Comment Code					
DT : Ditch					
Inspector Comment					
Ditch has encroached into landside toe and slope.

Looking upstream at irrigation at landside toe.

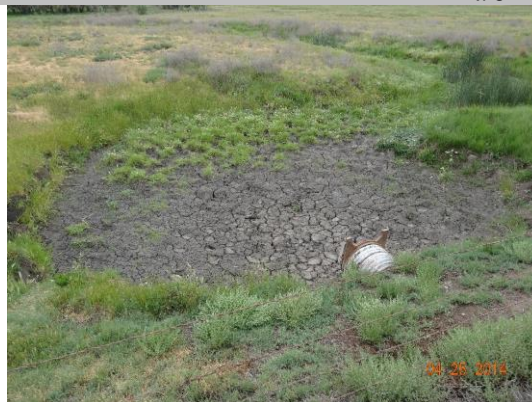
Photo 2 of 3 : UCIP_SP_2020_39273_65707.jpg

Flap gate visible on waterward side.

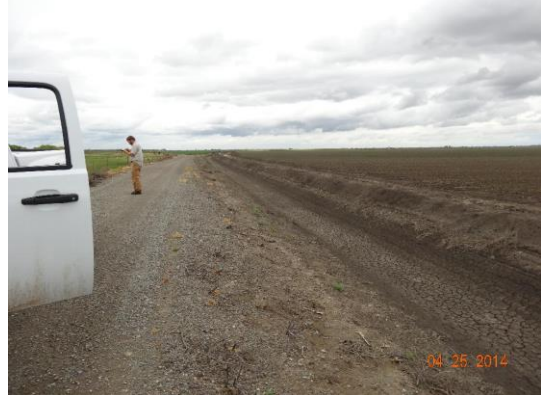
Photo 3 of 3 : UCIP_SP_2020_39273_65708.jpg

View of landward side.

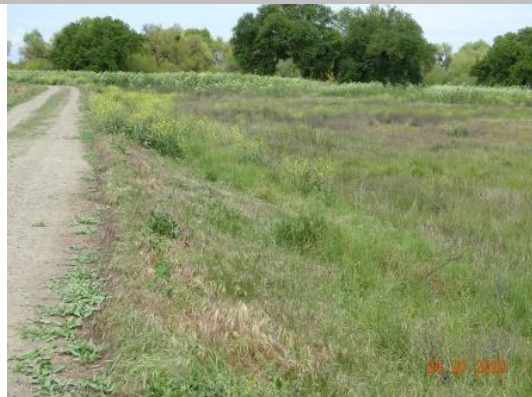
Photo 1 of 1 : SP_2020_NA0010_119_26_20200506_00069.jpg

LM Start	0.02	Rating **	U	Issue No.	26
LM End	2.27	Issue Type +	Ma	Location *	WS
Category	Earthen Levee			GPS Latitude/Longitude	
				Start	End
Item	Vegetation			37.296224 °	37.291772 °
				-120.880353 °	-120.851672 °
DWR ID	DWR_NA0010_02A_s_2020_26				
Comment Code					
V1 : Control annual grass and weeds on the levee slopes and easements.					
Inspector Comment

Looking downstream along the waterside slope. (Spring 2020)

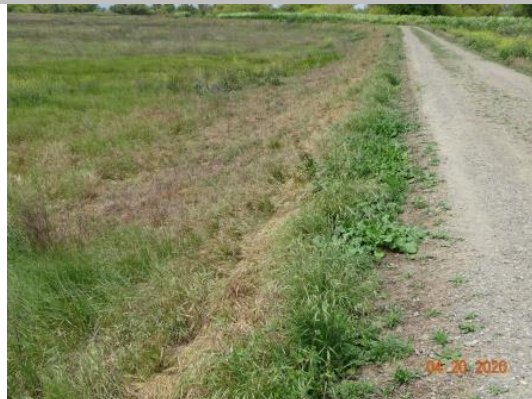
Photo 1 of 1 : SP_2020_NA0010_119_27_20200506_00068.jpg

LM Start	0.02	Rating **	U	Issue No.	27
LM End	2.27	Issue Type +	Ma	Location *	LS
Category	Earthen Levee			GPS Latitude/Longitude	
				Start	End
Item	Vegetation			37.296224 °	37.291772 °
				-120.880353 °	-120.851672 °
DWR ID	DWR_NA0010_02A_s_2020_27				
Comment Code					
V1 : Control annual grass and weeds on the levee slopes and easements.					
Inspector Comment

View of the landside slope looking downstream. (Spring 2020)

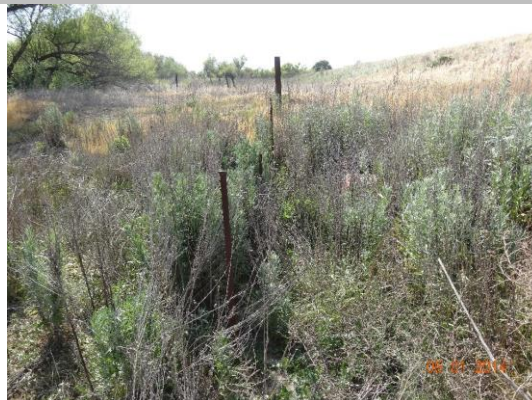
Photo 2 of 3 : UCIP_SP_2020_36503_66101.jpg

Fence along waterward side. No headwall was found on waterward side.

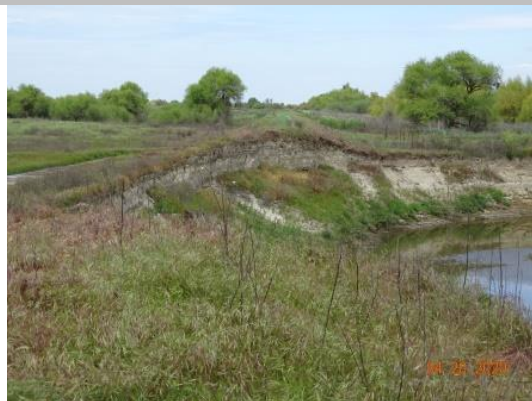
Photo 1 of 1 : SP_2020_NA0010_119_5_20200506_00070.jpg

LM Start	0.71	Rating **	U	Issue No.	5
LM End	0.78	Issue Type +	Ma	Location *	WS
Category	Earthen Levee			GPS Latitude/Longitude	
				Start	End
Item	Erosion / Bank Caving			37.287517 °	37.286543 °
				-120.874583 °	-120.873935 °
DWR ID	DWR_NA0010_02A_s_2012_5				
Comment Code					
E2 : Schedule repair of erosion site prior to the next inspection.					
Inspector Comment					
This section of the levee unit is in the process of being turned over to State Parks.

Looking downstream at erosion through the waterside slope and levee crown. (Spring 2020)

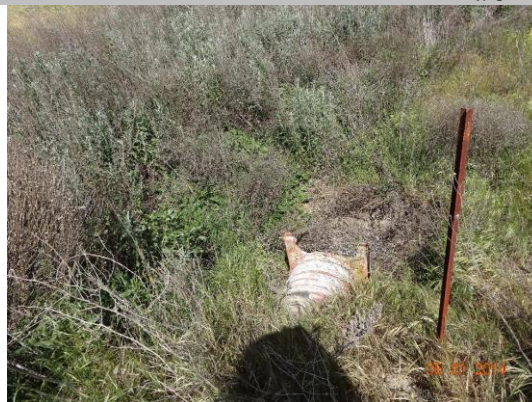
Photo 2 of 3 : UCIP_SP_2020_39363_66112.jpg

Pipe visible on waterward side.

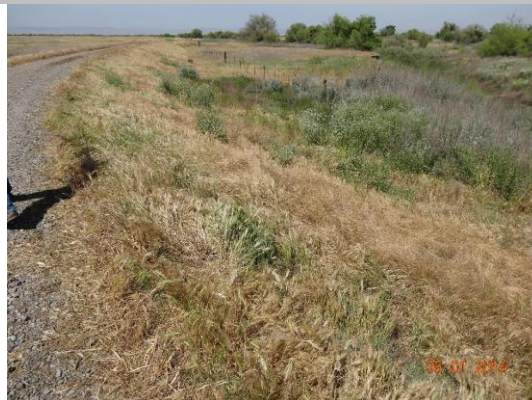
Photo 2 of 3 : UCIP_SP_2020_36507_66119.jpg

View of waterward side.

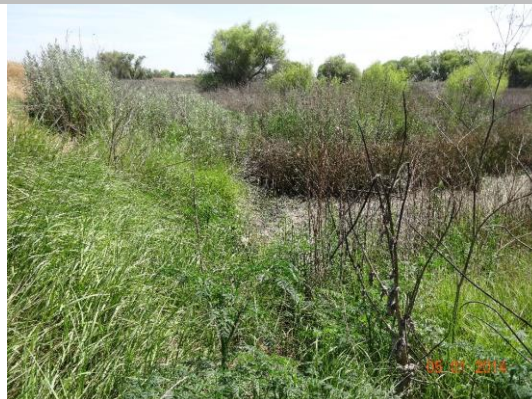
Photo 2 of 3 : UCIP_SP_2020_36508_66123.jpg

Dense vegetation along levee slope and toe.

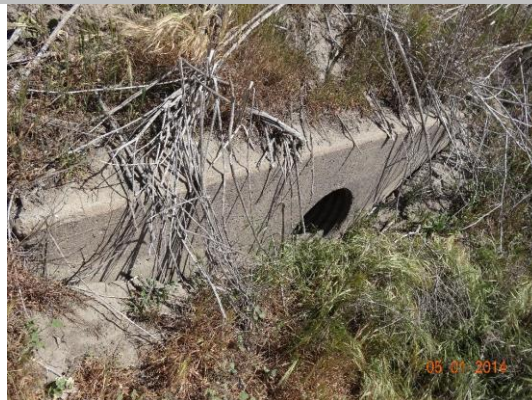
Photo 2 of 3 : UCIP_SP_2020_36509_66128.jpg

Comment Code						
Inspector Comment						
DS_ID:19658 FS_ID:36509 EP_NO: N/A Repair Type: Non-Urgent Crossing Status: Found UCIP Comments: 05/01/2014 Dense vegetation limits the inspector's visibility to identify signs of pipe failure (leaks) along the slope. Recommend removing vegetation along pipe alignment to conduct proper inspection of structure. (DWR UCIP - O. Magana) FIELD_STRUCT_DESC: 24-inch corrugated metal gravity drainage pipe through the levee, 10.7 feet below the crown. Flap gate on the waterside (WS) end. Brass cap No. 135 bench mark (BM) on the headwall on the landside (LS). [Additional Reference(s): DWR Levee Log, 2002. USACE San Joaquin O&M Manual 601.1, 1967, (HLM 1.86)]. FS Date: 5/1/2014

Concrete headwall visible on landward side.

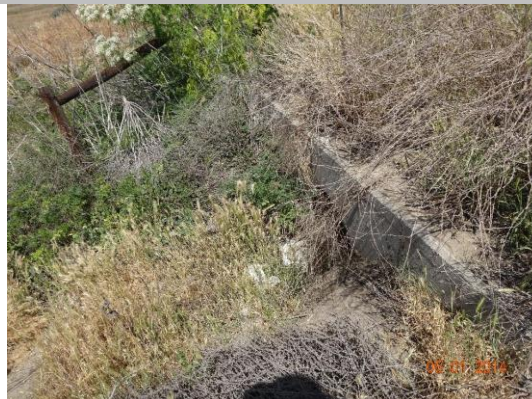
Photo 2 of 3 : UCIP_SP_2020_36510_66132.jpg

Concrete headwall visible on landward side.

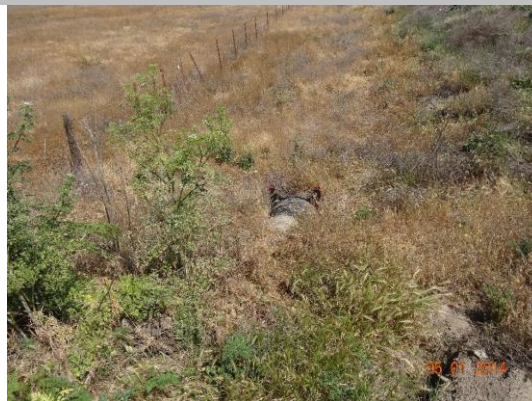
Photo 3 of 3 : UCIP_SP_2020_36510_66131.jpg

View of pipe through levee visible on waterward side.

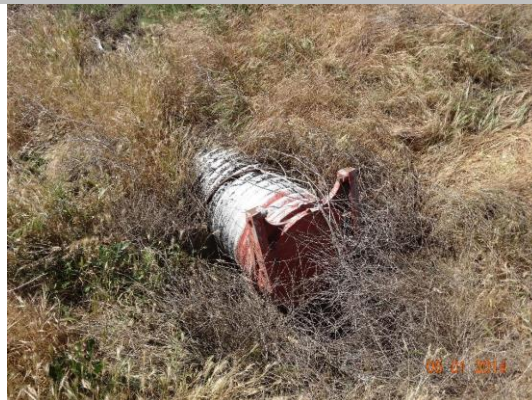
Photo 2 of 3 : UCIP_SP_2020_36511_66136.jpg

Comment Code						
Inspector Comment						
DS_ID:19660 FS_ID:36511 EP_NO: N/A Repair Type: Non-Urgent Crossing Status: Found UCIP Comments: 05/01/2014 Dense vegetation limits the inspector's visibility to identify signs of pipe failure (leaks) along the slope. Recommend removing vegetation along pipe alignment to conduct proper inspection of structure. (DWR UCIP - O. Magana) FIELD_STRUCT_DESC: 24-inch corrugated metal gravity drainage pipe through the levee, 7 feet below the crown. Flap gate on the waterside (WS) end. Brass cap No. 135 bench mark (BM) on the headwall on the landside (LS). [Additional Reference(s): DWR Levee Log, 2002. USACE San Joaquin O&M Manual 601.1, 1967, (HLM 2.32)]. FS Date: 5/1/2014

Flap gate visible on waterward side.

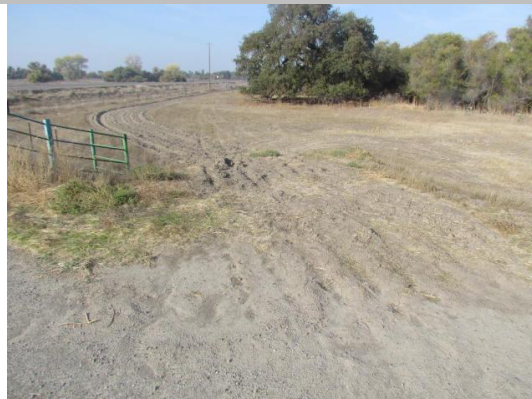
Photo 1 of 1 : SP_2020_NA0010_119_2_20200225_00001.jpg

LM Start	2.32	Rating **	M	Issue No.	2
LM End	2.32	Issue Type +	En	Location *	LS
Category	Earthen Levee			GPS Latitude/Longitude	
				Start	End
Item	Encroachments			37.291433 °	37.291433 °
				-120.850917 °	-120.850917 °
DWR ID	DWR_NA0010_02A_s_2012_2				
Comment Code					
RA : Ramp					
Inspector Comment					
Unauthorized ramps are located on the landside and waterside slopes.

Looking northeast at unauthorized ramp on landward slope.

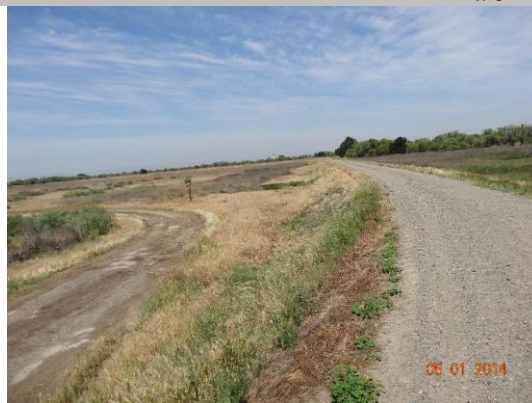
Photo 1 of 3 : UCIP_SP_2020_36512_66142.jpg

Comment Code						
Inspector Comment						
DS_ID:19661 FS_ID:36512 EP_NO: N/A Repair Type: Non-Urgent Crossing Status: Found UCIP Comments: 05/01/2014 Dense vegetation limits the inspector's visibility to identify signs of pipe failure (leaks) along the slope. Recommend removing vegetation along pipe alignment to conduct proper inspection of structure. (DWR UCIP - O. Magana) FIELD_STRUCT_DESC: 24-inch corrugated metal gravity drainage pipe through the levee, 10 feet below the crown. Flap gate on the waterside (WS) end. Brass cap No. 130 bench mark (BM) on the headwall on the landside (LS). [Additional Reference(s): DWR Levee Log, 2002. USACE San Joaquin O&M Manual 601.1, 1967, (HLM 2.59)]. FS Date: 5/1/2014

View of landward side.

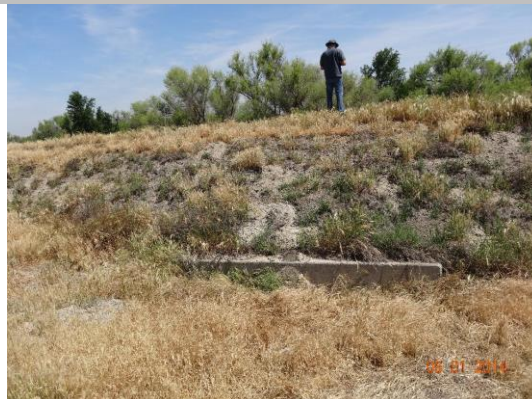
Photo 2 of 3 : UCIP_SP_2020_36512_66141.jpg

Concrete headwall visible on landward side.

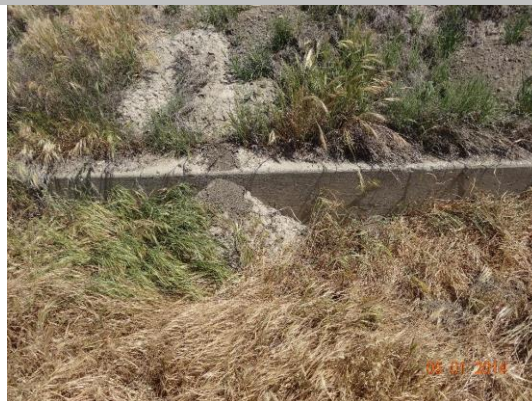
Photo 3 of 3 : UCIP_SP_2020_36512_66140.jpg

Non-functional crossing concrete headwall and inlet buried on landward side.

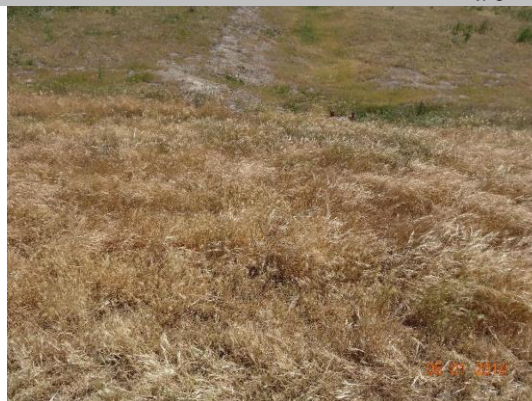
Photo 1 of 3 : UCIP_SP_2020_36513_66145.jpg

DS_ID:19662
FS_ID:36513
EP_NO: N/A
Repair Type: Non-Urgent
Crossing Status: Found
UCIP Comments: 05/01/2014 Dense vegetation limits the inspector's visibility to identify signs of pipe failure (leaks) along the slope. Recommend removing vegetation along pipe alignment to conduct proper inspection of structure. (DWR UCIP - O. Magana)
FIELD_STRUCT_DESC: 24-inch corrugated metal gravity drainage pipe through the levee, 10 feet below the crown. Flap gate on the waterside (WS) end. Brass cap No. 130 bench mark (BM) on the headwall on the landside (LS). [Additional Reference(s): DWR Levee Log, 2002. USACE San Joaquin O&M Manual 601.1, 1967, (HLM 2.96)].
FS Date: 5/1/2014

View of waterward side.

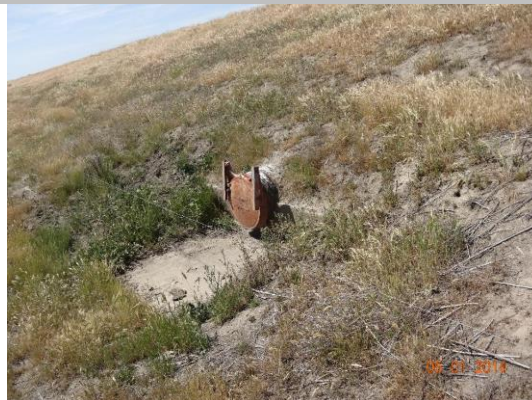
Photo 2 of 3 : UCIP_SP_2020_36513_66144.jpg

Flap gate visible on waterward side.

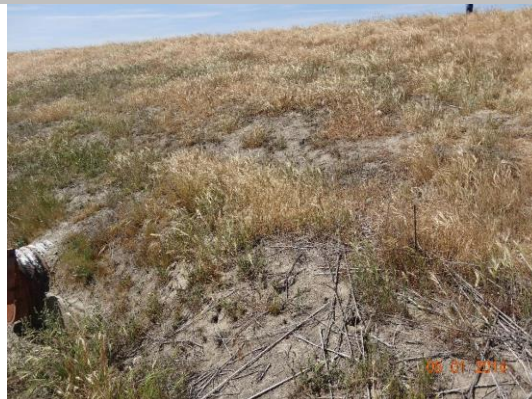
Photo 3 of 3 : UCIP_SP_2020_36513_66149.jpg

View of slope on waterward side.

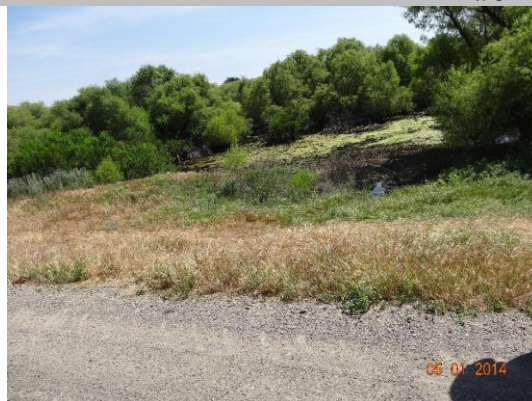
Photo 1 of 3 : UCIP_SP_2020_36514_66151.jpg

DS_ID:19665
 FS_ID:36514
 EP_NO: N/A
 Repair Type: Non-Urgent
 Crossing Status: Found
 UCIP Comments: 05/01/2014 Dense vegetation limits the inspector's visibility to identify signs of pipe failure (leaks) along the slope. Recommend removing vegetation along pipe alignment to conduct proper inspection of structure. (DWR UCIP - O. Magana)
 FIELD_STRUCT_DESC: 24-inch corrugated metal gravity drainage pipe through the levee, 12.4 feet below the crown. Flap gate on the waterside (WS) end. Brass cap No. 130 bench mark (BM) on the headwall on the landside (LS). [Additional Reference(s): DWR Levee Log, 2002. USACE San Joaquin O&M Manual 601.1, 1967, (HLM 3.29)].
 FS Date: 5/1/2014

View of waterward side.

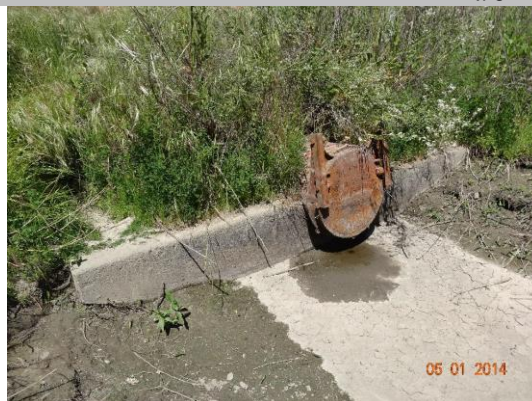
Photo 2 of 3 : UCIP_SP_2020_36514_66153.jpg

Flap gate visible on waterward side.

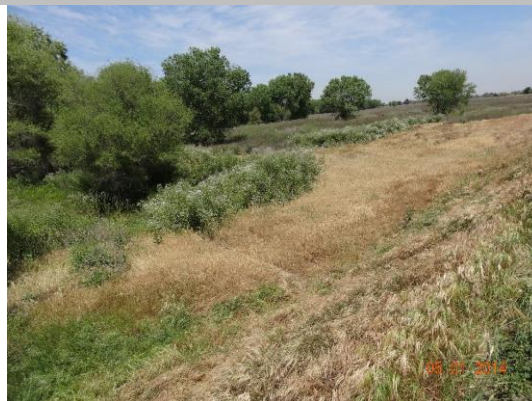
Photo 3 of 3 : UCIP_SP_2020_36514_66152.jpg

View of landward side.

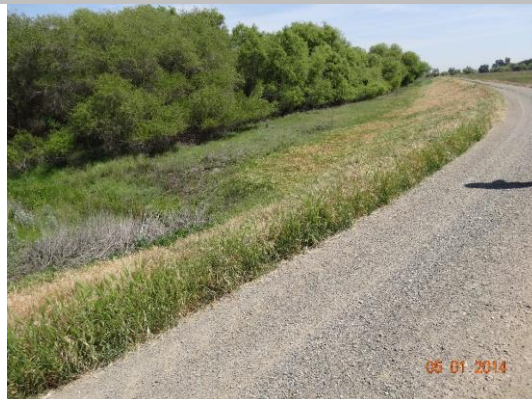
Photo 1 of 3 : UCIP_SP_2020_36515_66155.jpg

Comment Code						
Inspector Comment						
DS_ID:19666 FS_ID:36515 EP_NO: N/A Repair Type: Non-Urgent Crossing Status: Found UCIP Comments: 05/01/2014 Dense vegetation limits the inspector's visibility to identify signs of pipe failure (leaks) along the slope. Recommend removing vegetation along pipe alignment to conduct proper inspection of structure. (DWR UCIP - O. Magana) FIELD_STRUCT_DESC: 24-inch corrugated metal gravity drainage pipe through the levee, 10 feet below the crown. Flap gate on the waterside (WS) end. Brass cap No. 130 bench mark (BM) on the headwall on the landside (LS). [Additional Reference(s): DWR Levee Log, 2002. USACE San Joaquin O&M Manual 601.1, 1967, (HLM 3.62)]. FS Date: 5/1/2014

View of waterward side.

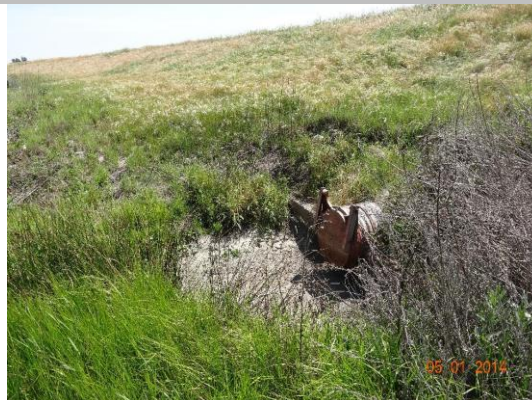
Photo 2 of 3 : UCIP_SP_2020_36515_66154.jpg

Flap gate visible on waterward side.

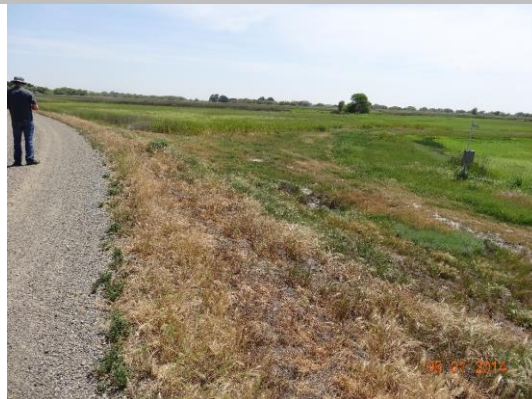
Photo 3 of 3 : UCIP_SP_2020_36515_66156.jpg

View of landward side.

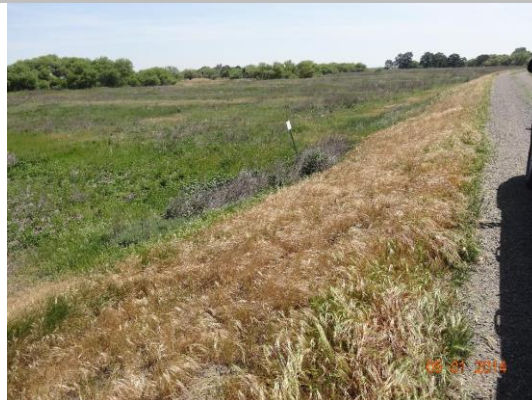
Photo 2 of 3 : UCIP_SP_2020_39364_66160.jpg

DS_ID:19667
FS_ID:39364
EP_NO: N/A
Repair Type: Non-Urgent
Crossing Status: Found
UCIP Comments: 05/01/2014 Signs of erosion or sink hole present on landward toe--Need to contact owner. Dense vegetation limits the inspector's visibility to identify signs of pipe failure (leaks) along the slope. Recommend removing vegetation along pipe alignment to conduct proper inspection of structure. (DWR UCIP - O. Magana)
FIELD_STRUCT_DESC: 24-inch corrugated metal gravity drainage pipe through the levee, 8.6 feet below the crown. Flap gate on the waterside (WS) end. Brass cap No. 130 bench mark (BM) on the headwall on the landside (LS). [Additional Reference(s): DWR Levee Log, 2002. USACE San Joaquin O&M Manual 601.1, 1967, (HLM 3.95)].
FS Date: 5/1/2014

View of waterward side.

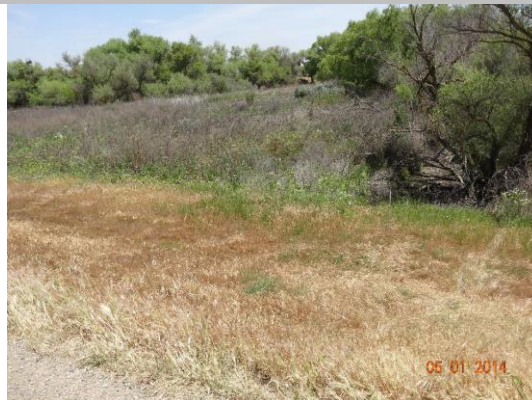
Photo 2 of 2 : UCIP_SP_2020_36518_66170.jpg

DS_ID:19669
FS_ID:36518
EP_NO: N/A
Repair Type: Non-Urgent
Crossing Status: Found
UCIP Comments: 05/01/2014 Dense vegetation limits the inspector's visibility to identify signs of pipe failure (leaks) along the slope. Recommend removing vegetation along pipe alignment to conduct proper inspection of structure. (DWR UCIP - O. Magana)
FIELD_STRUCT_DESC: 24-inch corrugated metal gravity drainage pipe through the levee, 7.7 feet below the crown. Flap gate on the waterside (WS) end. Brass cap No. 125 bench mark (BM) on the headwall on the landside (LS). [Additional Reference(s): DWR Levee Log, 2002. USACE San Joaquin O&M Manual 601.1, 1967, (HLM 6.06)].
FS Date: 5/1/2014

View of waterward side.

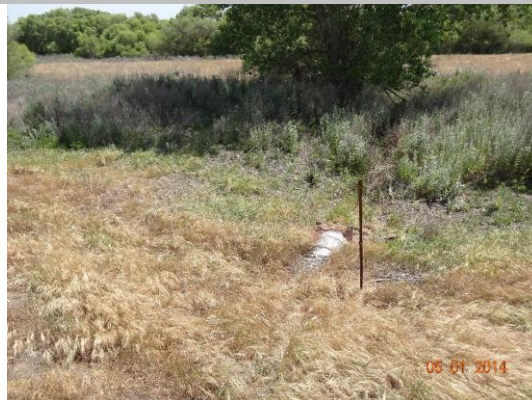
Photo 2 of 3 : UCIP_SP_2020_36519_66172.jpg

Comment Code						
Inspector Comment						
DS_ID:19670 FS_ID:36519 EP_NO: N/A Repair Type: Non-Urgent Crossing Status: Found UCIP Comments: 05/01/2014 Dense vegetation limits the inspector's visibility to identify signs of pipe failure (leaks) along the slope. Recommend removing vegetation along pipe alignment to conduct proper inspection of structure. (DWR UCIP - O. Magana) FIELD_STRUCT_DESC: 24-inch corrugated metal gravity drainage pipe through the levee, 7.7 feet below the crown. Flap gate on the waterside (WS) end. Brass cap No. 125 bench mark (BM) on the headwall on the landside (LS). [Additional Reference(s): DWR Levee Log, 2002. USACE San Joaquin O&M Manual 601.1, 1967, (HLM 6.50)]. FS Date: 5/1/2014

Crossing and flap gate visible on waterward side.

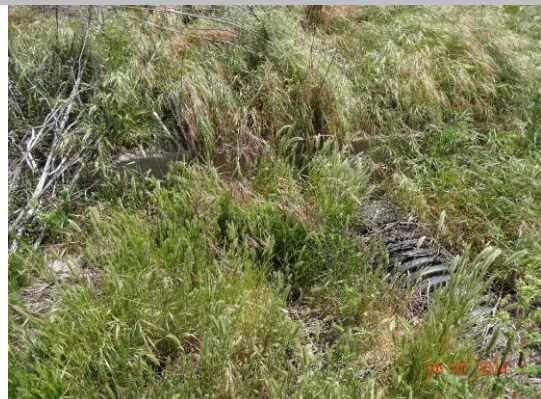
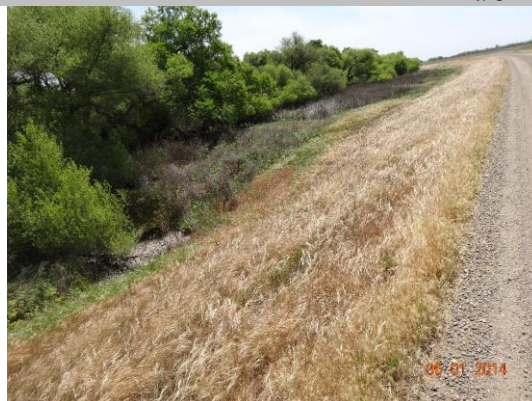
DS_ID:19671
FS_ID:39365
EP_NO: N/A
Repair Type: Non-Urgent
Crossing Status: Found
UCIP Comments: 05/01/2014 Dense vegetation limits the inspector's visibility to identify signs of pipe failure (leaks) along the slope. Recommend removing vegetation along pipe alignment to conduct proper inspection of structure. Pipe extension visible on landward side-- need to contact owner for additional information about extension/modification. (DWR UCIP - O. Magana)
FIELD_STRUCT_DESC: 24-inch corrugated metal gravity drainage pipe through the levee, 12.6 feet below the crown. Flap gate on the waterside (WS) end. Brass cap No. 125 bench mark (BM) on the headwall on the landside (LS). [Additional Reference(s): DWR Levee Log, 2002. USACE San Joaquin O&M Manual 601.1, 1967, (HLM 7.05)].
FS Date: 5/1/2014

View of landward side.

Pipe extension visible on landward side attached to inlet at concrete headwall.

View of waterward side.

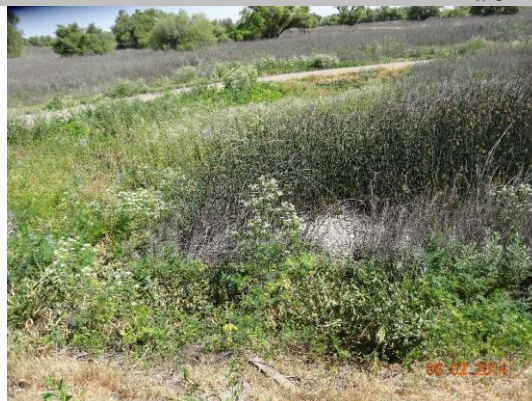
DS_ID:19673
 FS_ID:36521
 EP_NO: N/A
 Repair Type: Non-Urgent
 Crossing Status: Found
 UCIP Comments: 05/01/2014 Dense vegetation limits the inspector's visibility to identify signs of pipe failure (leaks) along the slope. Recommend removing vegetation along pipe alignment to conduct proper inspection of structure. (DWR UCIP - O. Magana)
 FIELD_STRUCT_DESC: 24-inch corrugated metal gravity drainage pipe through the levee, 8 feet below the crown. Flap gate on the waterside (WS) end. Brass cap No. 125 bench mark (BM) on the headwall on the landside (LS). [Additional Reference(s): DWR Levee Log, 2002. USACE San Joaquin O&M Manual 601.1, 1967, (HLM 7.77)].
 FS Date: 5/1/2014

View of waterward side.

View of landward side.

View of waterward side--photo taken from levee toe looking towards alignment of crossing.

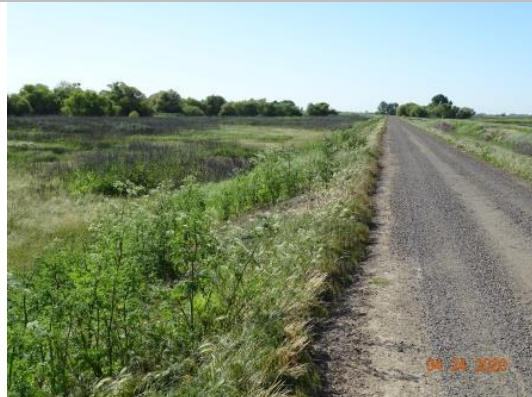
Photo 1 of 1 : SP_2020_NA0010_120_15_20200506_00049.jpg

LM Start	7.87	Rating **	U	Issue No.	15
LM End	13.73	Issue Type +	Ma	Location *	WS
Category	Earthen Levee			GPS Latitude/Longitude	
				Start	End
Item	Vegetation			37.231206 °	37.172443 °
				-120.811800 °	-120.761150 °
DWR ID	DWR_NA0010_02B_s_2020_15				
Comment Code					
V1 : Control annual grass and weeds on the levee slopes and easements.					
Inspector Comment

View of the waterside slope looking upstream. (Spring 2020)

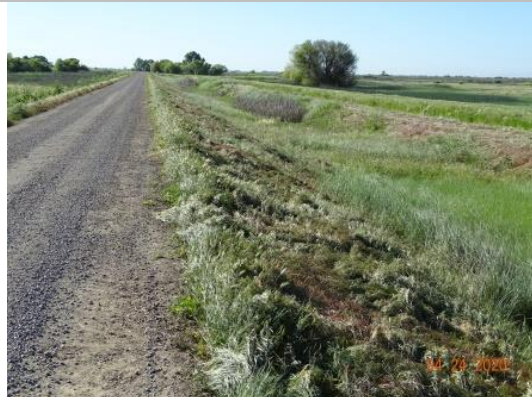
Photo 1 of 1 : SP_2020_NA0010_120_18_20200506_00050.jpg

LM Start	7.87	Rating **	U	Issue No.	18
LM End	13.73	Issue Type +	Ma	Location *	LS
Category	Earthen Levee			GPS Latitude/Longitude	
				Start	End
Item	Vegetation			37.231205 °	37.172443 °
				-120.811800 °	-120.761150 °
DWR ID	DWR_NA0010_02B_s_2020_18				
Comment Code					
V1 : Control annual grass and weeds on the levee slopes and easements.					
Inspector Comment

Looking upstream along the landside slope. (Spring 2020)

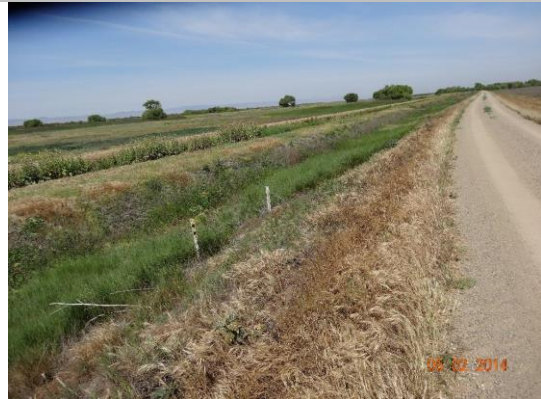
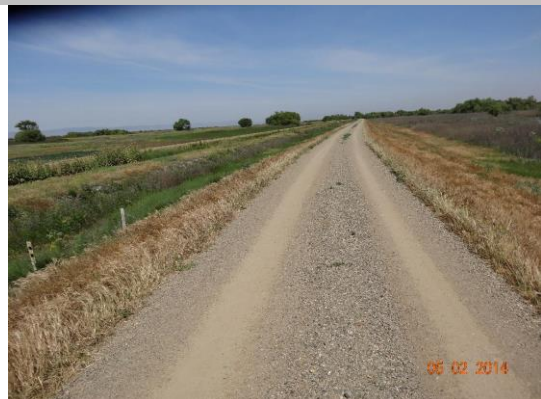
DS_ID:19674
FS_ID:39366
EP_NO: N/A
Repair Type: Non-Urgent
Crossing Status: Found
UCIP Comments: 05/14/2014 Dense vegetation limits the inspector's visibility to identify signs of pipe failure (leaks) along the slope and landward headwall. Recommend removing vegetation along pipe alignment and toe to conduct proper inspection of structure. Sediment buildup in pipe visible from landward side--recommend clearing. (DWR UCIP - O. Magana)
FIELD_STRUCT_DESC: 24-inch corrugated metal gravity drainage pipe through the levee, 9 feet below the crown. Flap gate on the waterside (WS) end. Brass cap No. 120 bench mark (BM) on the headwall on the landside (LS). [Additional Reference(s): DWR Levee Log, 2002. USACE San Joaquin O&M Manual 601.1, 1967, (HLM 8.16)].
FS Date: 5/14/2014

View of landward side.

Overview of levee crown at crossing.

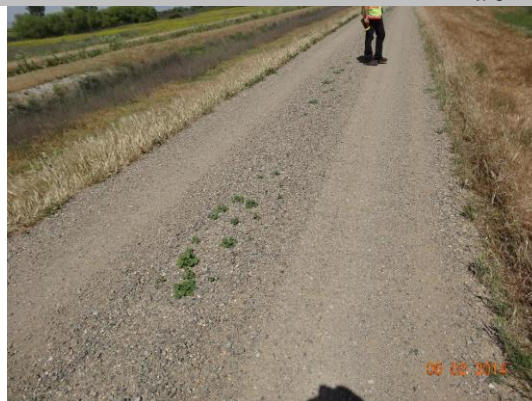
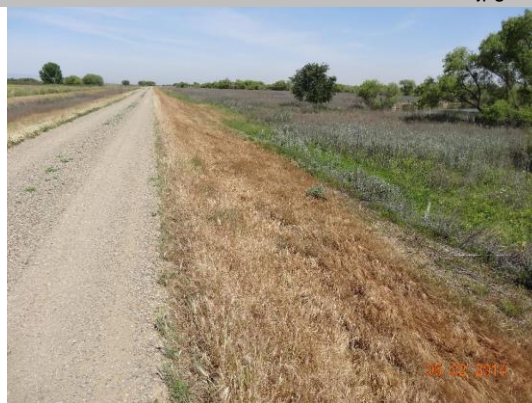
LM Start	8.46	Rating **	M	Issue No.	27 (cont)
LM End	8.46	Issue Type +	Ma	Location *	
Category	Supplemental		GPS Latitude/Longitude		
			Start	End	
Item	DWR UCIP LMA Responsibility		37.225241 °	37.225241 °	
			-120.804286 °	-120.804286 °	
DWR ID	19675

Overview of levee crown at crossing.

View of waterward side.

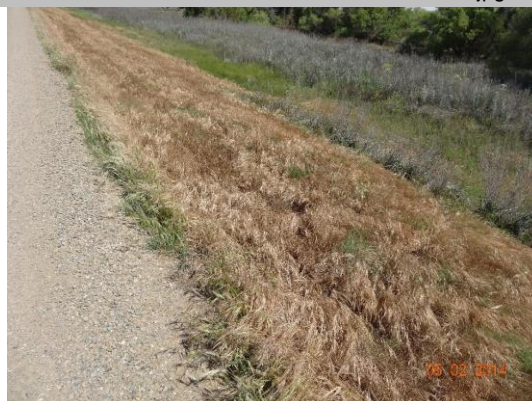
DS_ID:19676
FS_ID:42503
EP_NO: N/A
Repair Type: Non-Urgent
Crossing Status: Found
UCIP Comments: 05/14/2014 Dense vegetation limits the inspector's visibility to identify signs of pipe failure (leaks) along the slope. Recommend removing vegetation along pipe alignment to conduct proper inspection of structure. Burrow activity present on waterward slope. (DWR UCIP - O. Magana)
FIELD_STRUCT_DESC: 24-inch corrugated metal gravity drainage pipe through the levee, 8.8 feet below the crown. Flap gate on the waterside (WS) end. Brass cap No. 120 bench mark (BM) on the headwall on the landside (LS). [Additional Reference(s): DWR Levee Log, 2002. USACE San Joaquin O&M Manual 601.1, 1967, (recorded as HLM 9.86 should be 8.86)].
FS Date: 5/14/2014

View of landward side.

View of waterward side.

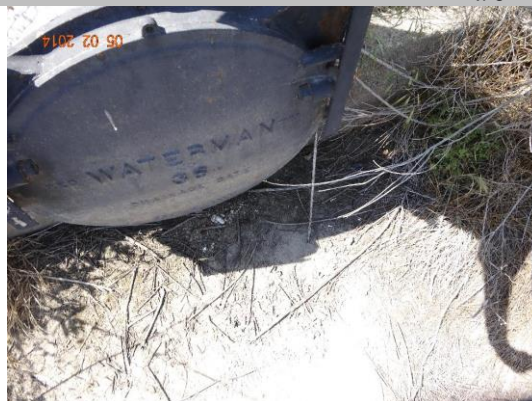
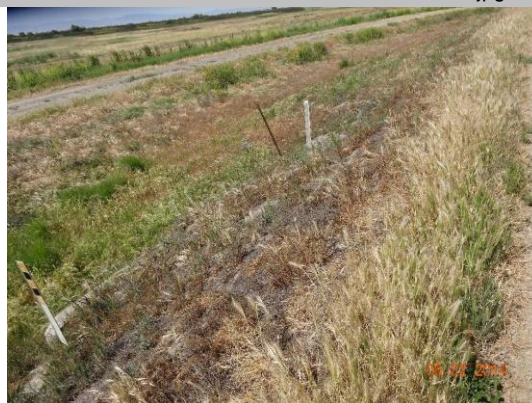
LM Start	9.00	Rating **	M	Issue No.	29 (cont)
LM End	9.00	Issue Type +	Ma	Location *	
Category	Supplemental		GPS Latitude/Longitude		
			Start	End	
Item	DWR UCIP LMA Responsibility		37.220888 °	37.220888 °	
			-120.796394 °	-120.796394 °	
DWR ID	19677

View of flap gate visible from waterward side.

View of landward side.

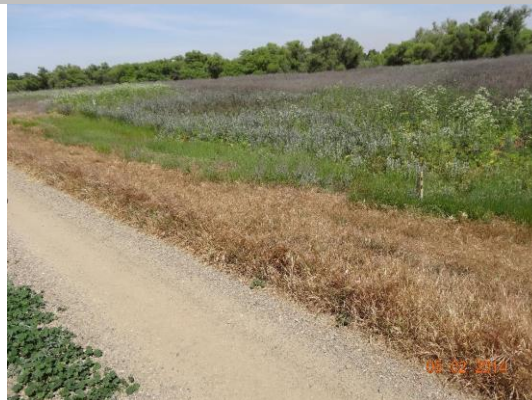
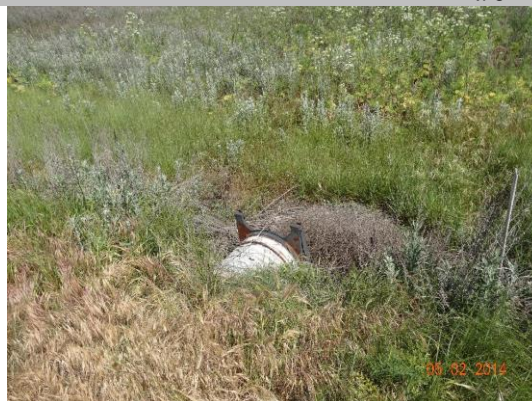
Comment Code						
Inspector Comment						
DS_ID:19678 FS_ID:40443 EP_NO: N/A Repair Type: Non-Urgent Crossing Status: Found UCIP Comments: 05/14/2014 Dense vegetation limits the inspector's visibility to identify signs of pipe failure (leaks) along the slope. Recommend removing vegetation along pipe alignment to conduct proper inspection of structure. (DWR UCIP - O. Magana) FIELD_STRUCT_DESC: 24-inch corrugated metal gravity drainage pipe through the levee, 8 feet below the crown. Flap gate on the waterside (WS) end. Brass cap No. 120 bench mark (BM) on the headwall on the landside (LS). [Additional Reference(s): DWR Levee Log, 2002. USACE San Joaquin O&M Manual 601.1, 1967, (HLM 9.20)]. FS Date: 5/14/2014

View of landward side.

View of waterward side.

Pipe visible on waterward side.

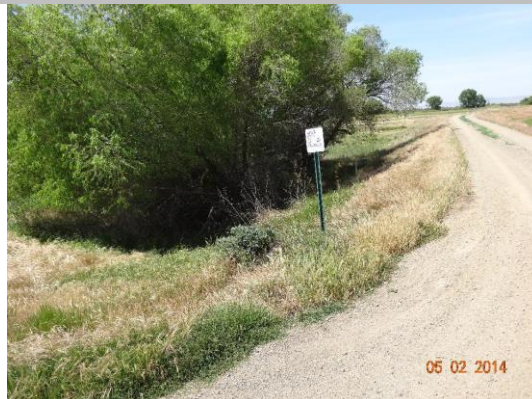
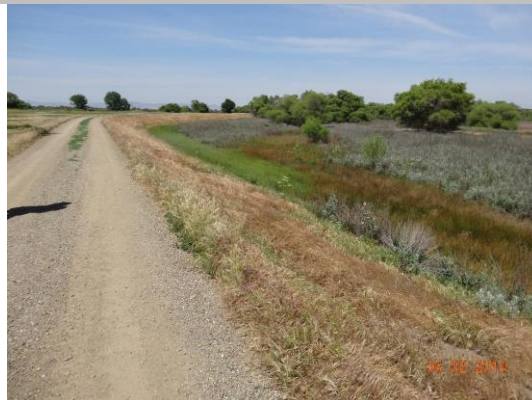
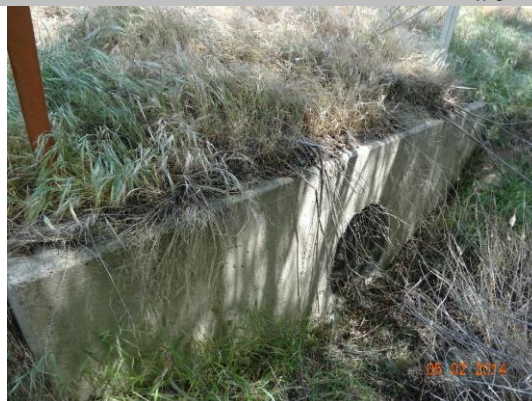
Comment Code						
Inspector Comment						
DS_ID:19686 FS_ID:36527 EP_NO: N/A Repair Type: Non-Urgent Crossing Status: Found UCIP Comments: 05/14/2014 Dense vegetation limits the inspector's visibility to identify signs of pipe failure (leaks) along the slope. Recommend removing vegetation along pipe alignment to conduct proper inspection of structure. (DWR UCIP - O. Magana) FIELD_STRUCT_DESC: 24-inch corrugated metal gravity drainage pipe through the levee, 9 feet below the crown. Flap gate on the waterside (WS) end. Brass cap No. 115 bench mark (BM) on the headwall on the landside (LS). [Additional Reference(s): DWR Levee Log, 2002. USACE San Joaquin O&M Manual 601.1, 1967, (HLM 9.46)]. FS Date: 5/14/2014

View of landward side.

View of waterward side.

Concrete headwall visible on landward side.

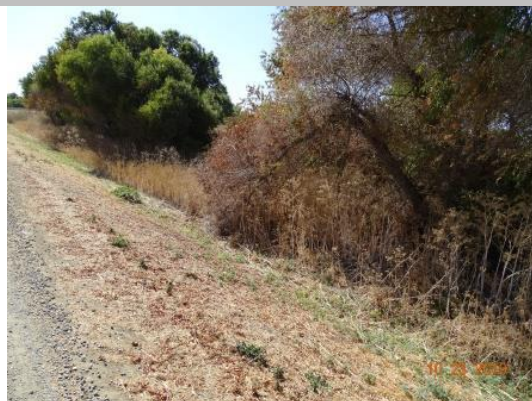
Photo 1 of 1 : SP_2020_NA0010_120_20_20200225_00008.jpg

LM Start	9.90	Rating **	M	Issue No.	20
LM End	9.90	Issue Type +	Ma	Location *	LS
Category	Earthen Levee			GPS Latitude/Longitude	
				Start	End
Item	Trim / Thin Trees			37.216923 °	37.216923 °
				-120.784007 °	-120.784007 °
DWR ID	DWR_NA0010_02B_f_2019_20				
Comment Code					
T1 : Trim trees to at least five feet above ground level.					
Inspector Comment					
Dead tree limb hanging on landside toe.

View of broken tree limb hanging over landside slope and toe. (Fall 2019)

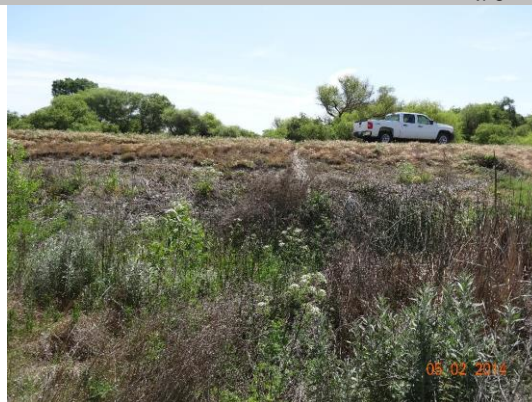
Comment Code						
Inspector Comment						
DS_ID:19687 FS_ID:36528 EP_NO: N/A Repair Type: Non-Urgent Crossing Status: Found UCIP Comments: 05/14/2014 Dense vegetation limits the inspector's visibility to identify signs of pipe failure (leaks) along the slope. Recommend removing vegetation along pipe alignment to conduct proper inspection of structure. (DWR UCIP - O. Magana) FIELD_STRUCT_DESC: 24-inch corrugated metal gravity drainage pipe through the levee, 11.7 feet below the crown. Flap gate on the waterside (WS) end. Brass cap No. 115 bench mark (BM) on the headwall on the landside (LS). [Additional Reference(s): DWR Levee Log, 2002. USACE San Joaquin O&M Manual 601.1, 1967, (HLM 10.12)]. FS Date: 5/14/2014

Overview of waterward side.

View of waterward slope.

View of waterward side.

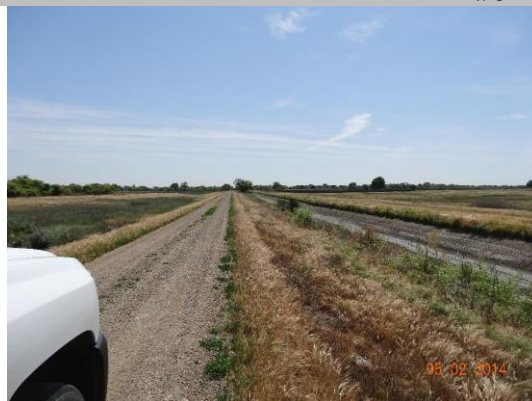
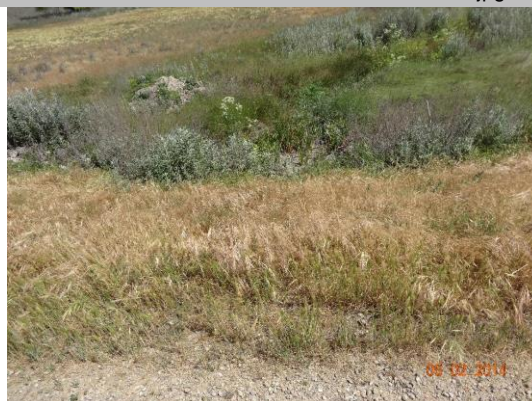
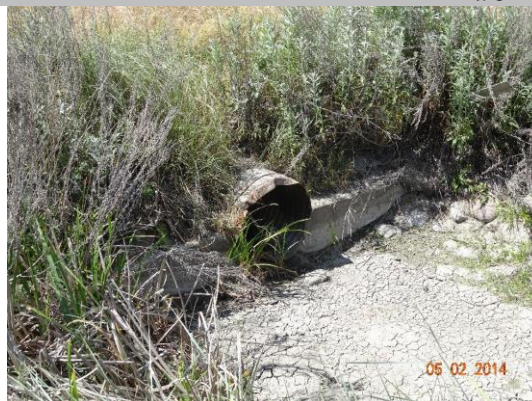
Comment Code						
Inspector Comment						
DS_ID:19688 FS_ID:42504 EP_NO: N/A Repair Type: Non-Urgent Crossing Status: Found UCIP Comments: 05/14/2014 Dense vegetation limits the inspector's visibility to identify signs of pipe failure (leaks) along the slope. Recommend removing vegetation along pipe alignment to conduct proper inspection of structure. Sediment buildup in pipe visible on landward side--recommend clearing. (DWR UCIP - O. Magana) FIELD_STRUCT_DESC: 24-inch corrugated metal gravity drainage pipe through the levee, 8 feet below the crown. Flap gate on the waterside (WS) end. Brass cap No. 115 bench mark (BM) on the headwall on the landside (LS). [Additional Reference(s): DWR Levee Log, 2002. USACE San Joaquin O&M Manual 601.1, 1967, (HLM 10.81)]. FS Date: 5/14/2014

View of landward side.

View of waterward side.

View of pipe visible on waterward side.

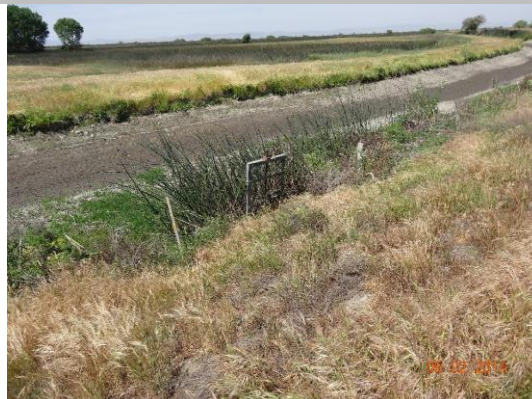
Photo 1 of 3 : UCIP_SP_2020_36530_66236.jpg

Comment Code						
Inspector Comment						
DS_ID:19689 FS_ID:36530 EP_NO: N/A Repair Type: Non-Urgent Crossing Status: Found UCIP Comments: 05/14/2014 Dense vegetation limits the inspector's visibility to identify signs of pipe failure (leaks) along the slope. Recommend removing vegetation along pipe alignment to conduct proper inspection of structure. (DWR UCIP - O. Magana) FIELD_STRUCT_DESC: 24-inch corrugated metal gravity drainage pipe through the levee, 8 feet below the crown. Flap gate on the waterside (WS) end. Brass cap No. 115 bench mark (BM) on the headwall on the landside (LS). [Additional Reference(s): DWR Levee Log, 2002. USACE San Joaquin O&M Manual 601.1, 1967, (HLM 11.17)]. FS Date: 5/14/2014

View of landward slope.

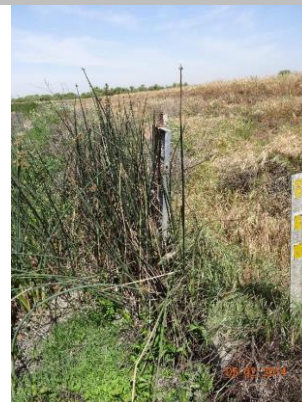
Photo 2 of 3 : UCIP_SP_2020_36530_66235.jpg

Slide gate visible on landward side blocked by vegetation.

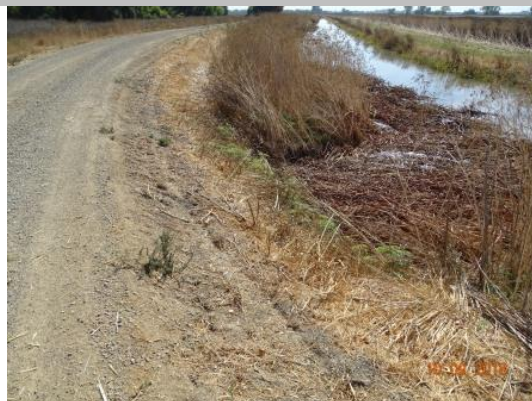
Photo 1 of 1 : SP_2020_NA0010_120_21_20200225_00009.jpg

LM Start	11.39	Rating **	U	Issue No.	21
LM End	11.39	Issue Type +	Ma	Location *	LS
Category	Earthen Levee			GPS Latitude/Longitude	
				Start	End
Item	Erosion / Bank Caving			37.201839 °	37.201839 °
				-120.768489 °	-120.768489 °
DWR ID	DWR_NA0010_02B_f _ 2018_21				
Comment Code					
E2 : Schedule repair of erosion site prior to the next inspection.					
Inspector Comment					
Erosion occurring into the landside slope of levee.

Erosion into landside slope. Looking upstream. (Fall 2018)

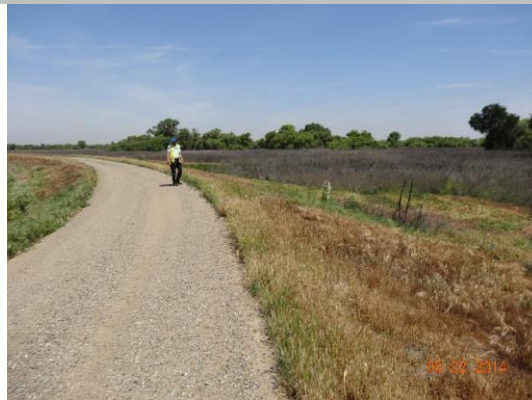
Photo 2 of 3 : UCIP_SP_2020_36531_66240.jpg

View of waterward side.

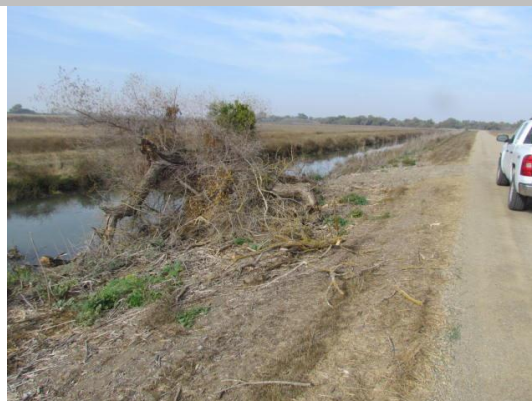
Photo 1 of 1 : SP_2020_NA0010_120_1_20200225_00001.jpg

LM Start	12.21	Rating **	M	Issue No.	1
LM End	12.21	Issue Type +	Ma	Location *	LS
Category	Earthen Levee			GPS Latitude/Longitude	
				Start	End
Item	Encroachments			37.191528 °	37.191528 °
				-120.764541 °	-120.764541 °
DWR ID	DWR_NA0010_02B_f_2014_1				
Comment Code					
TR : Tree or limb					
Inspector Comment					
Fallen tree limbs are located on the landside slope.

Looking northwest at tree limb on landward slope.

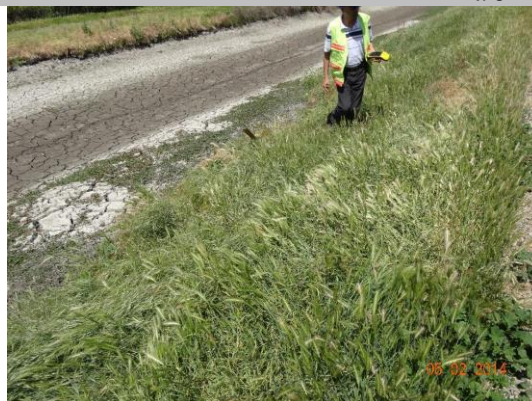
Photo 1 of 3 : UCIP_SP_2020_39370_66245.jpg

Comment Code						
Inspector Comment						
DS_ID:19663 FS_ID:39370 EP_NO: N/A Repair Type: Non-Urgent Crossing Status: Found UCIP Comments: 05/14/2014 Dense vegetation limits the inspector's visibility to identify signs of pipe failure (leaks) along the slope. Recommend removing vegetation along pipe alignment to conduct proper inspection of structure. Sediment buildup in pipe--recommend clearing. (DWR UCIP - O. Magana) FIELD_STRUCT_DESC: 24-inch corrugated metal gravity drainage pipe through the levee, 6.5 feet below the crown. Slide gate in a pipe riser on the waterside (WS) slope. [Additional Reference(s): DWR Levee Log, 2002. USACE San Joaquin O&M Manual 601.1, 1967, (recorded as HLM 13.32 should be 13.22)]. FS Date: 5/14/2014

View of landward side.

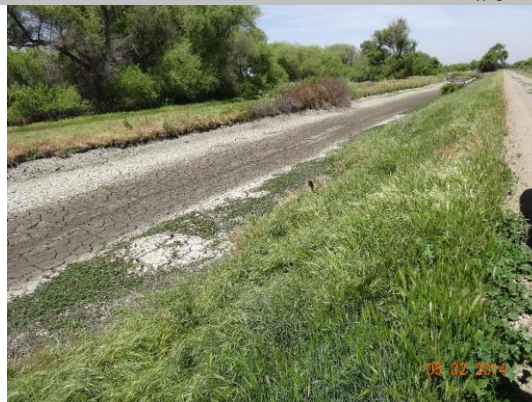
Photo 2 of 3 : UCIP_SP_2020_39370_66244.jpg

Overview of landward slope.

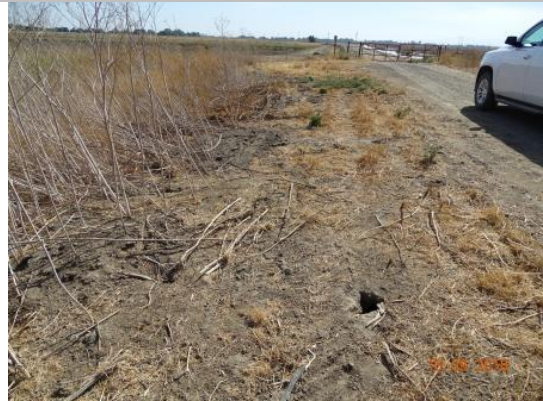
Photo 1 of 1 : SP_2020_NA0010_120_22_20200225_00011.jpg

LM Start	13.73	Rating **	M	Issue No.	22
LM End	13.73	Issue Type +	Ma	Location *	WS
Category	Earthen Levee			GPS Latitude/Longitude	
				Start	End
Item	Animal Control			37.172387 °	37.172387 °
				-120.761190 °	-120.761190 °
DWR ID	DWR_NA0010_02B_f_2018_22				
Comment Code					
A1 : Exterminate rodents and backfill and compact or grout burrows.					
Inspector Comment					
There are several rodent burrows observed at this location.

View of waterside slope looking upstream. (Fall 2018)

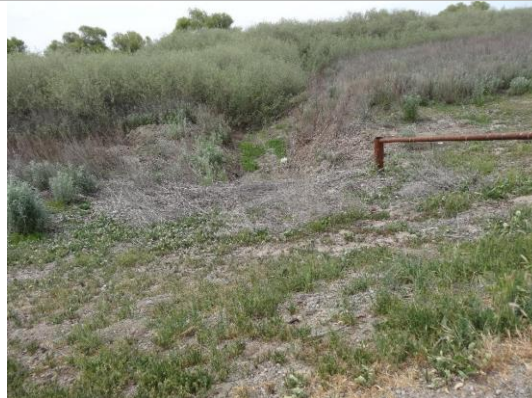
Photo 2 of 3 : UCIP_SP_2020_34083_61940.jpg

View of waterward side.

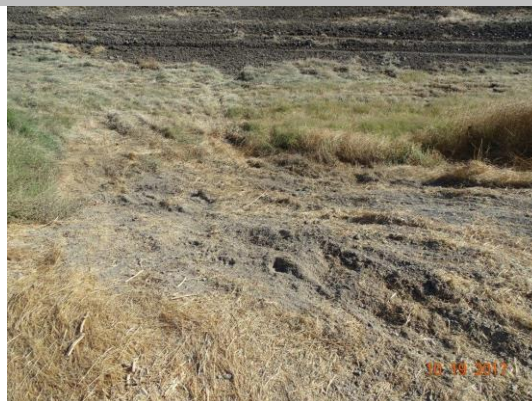
Photo 1 of 1 : SP_2020_NA0010_121_6_20200225_00002.jpg

LM Start	0.43	Rating **	M	Issue No.	6
LM End	0.43	Issue Type +	Ma	Location *	LS
Category	Earthen Levee			GPS Latitude/Longitude	
				Start	End
Item	Slope Stability			37.106121 °	37.106121 °
				-120.585680 °	-120.585680 °
DWR ID	DWR_NA0010_03_f_2017_6				
Comment Code					
S3 : Repair the levee slope damaged by vehicle traffic and prevent access where possible.					
Inspector Comment

Looking east at the landside slope.

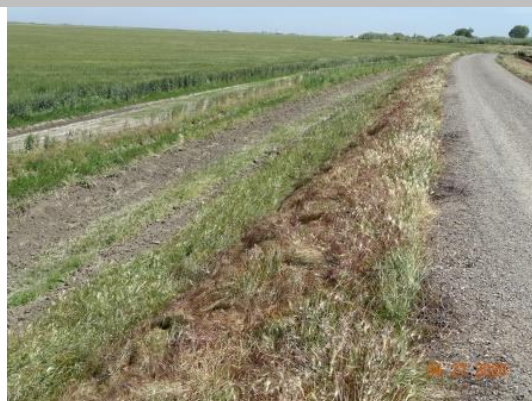
Photo 1 of 1 : SP_2020_NA0010_121_12_20200506_00021.jpg

LM Start	0.43	Rating **	M	Issue No.	12
LM End	1.89	Issue Type +	Ma	Location *	LS
Category	Earthen Levee			GPS Latitude/Longitude	
				Start	End
Item	Vegetation			37.106076 °	37.090204 °
				-120.585617 °	-120.570148 °
DWR ID	DWR_NA0010_03_s_2020_12				
Comment Code					
V1 : Control annual grass and weeds on the levee slopes and easements.					
Inspector Comment

View along the landside slope looking upstream. (Spring 2020)

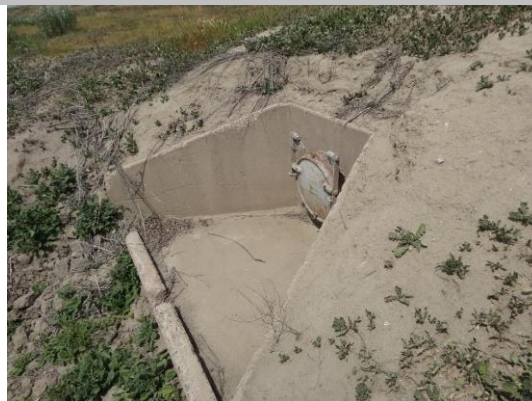
Photo 2 of 3 : UCIP_SP_2020_36534_66249.jpg

Concrete structure located on waterward side.

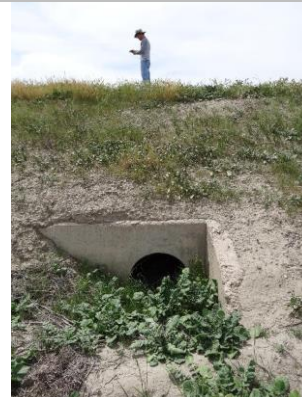
Photo 3 of 3 : UCIP_SP_2020_36534_66251.jpg

View of landward slope.

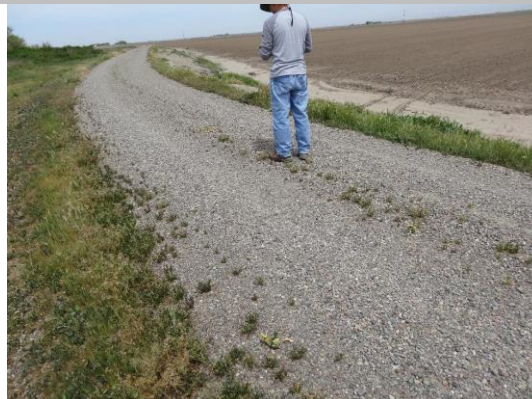
Photo 1 of 3 : UCIP_SP_2020_39371_66252.jpg

LM Start	1.71	Rating **	M	Issue No.	70	
LM End	1.71	Issue Type +	Ma	Location *		
Category	Supplemental			GPS Latitude/Longitude		
				Start	End	
Item	DWR UCIP LMA Responsibility			37.092079 °	37.092079 °	
				-120.572316 °	-120.572316 °	
DWR ID	19693					
Comment Code						
Inspector Comment						
DS_ID:19693 FS_ID:39371 EP_NO: N/A Repair Type: Non-Urgent Crossing Status: Found UCIP Comments: 04/17/2014 Sediment buildup in pipe visible from landward side--recommend clearing. (DWR UCIP - O. Magana) FIELD_STRUCT_DESC: 24-inch corrugated metal gravity drainage pipe through the levee, 6.8 feet below the crown. Flap gate on the waterside (WS) end. [Additional Reference(s): DWR Levee Log, 2002. USACE San Joaquin O&M Manual 601.1, 1967, (HLM 1.72)]. FS Date: 4/17/2014

View of levee crown at crossing.

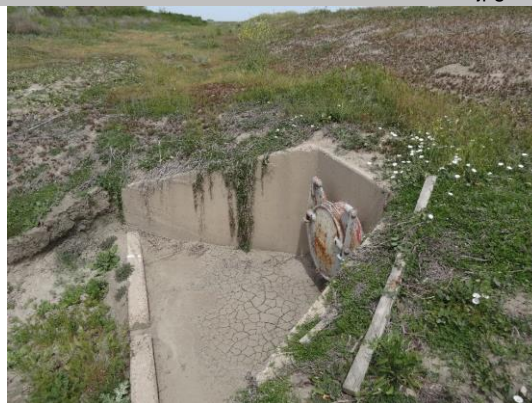
Photo 2 of 3 : UCIP_SP_2020_39371_66254.jpg

Concrete structure located on waterward side.

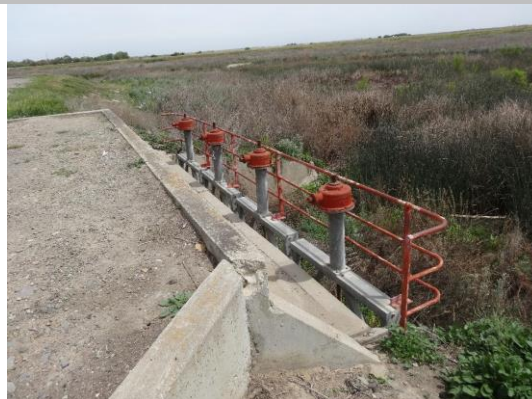
Photo 3 of 3 : UCIP_SP_2020_40529_61967.jpg

Concrete headwall located on waterward side.

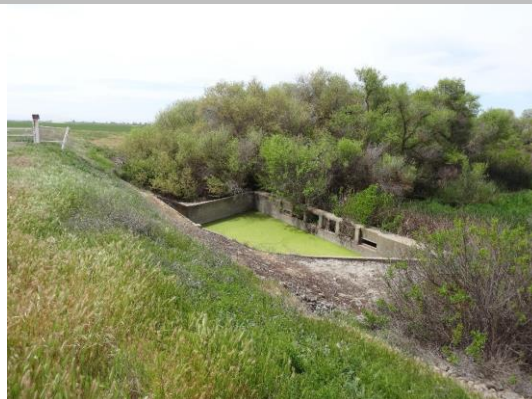
Photo 1 of 3 : UCIP_SP_2020_36875_67308.jpg

DS_ID:24856
FS_ID:36875
EP_NO: 5024
Repair Type: Non-Urgent
Crossing Status: Found
UCIP Comments: 10/27/2017 This structure is inspected annually under the Structure and Channel Summer Inspection (part of the Levee Inspection Program) conducted by the DWR Flood Project Integrity and Inspection Branch (FPIIB). (DWR UCIP - O. Magana)
04/17/2014 Slide gates blocked by sediment. Recommend contacting owner to determine status of crossing. Crossing appears to be abandoned. (DWR UCIP - O. Magana)
FIELD_STRUCT_DESC: [San Joaquin River Diversion Structure] 2 of 4: 72-inch by 60-inch reinforced concrete box gravity drainage culvert through the levee, 21 feet below the crown. Slide gate on the waterside (WS). Concrete headwall on each end. Landside (LS) slope cobble revetted. Flashboards on the downstream side of the structure.
FS Date: 4/17/2014

View of concrete structure located on landward side.
